Quick leak detection and repair of oil cables

Asset Management & Services
Emergency Response Solutions

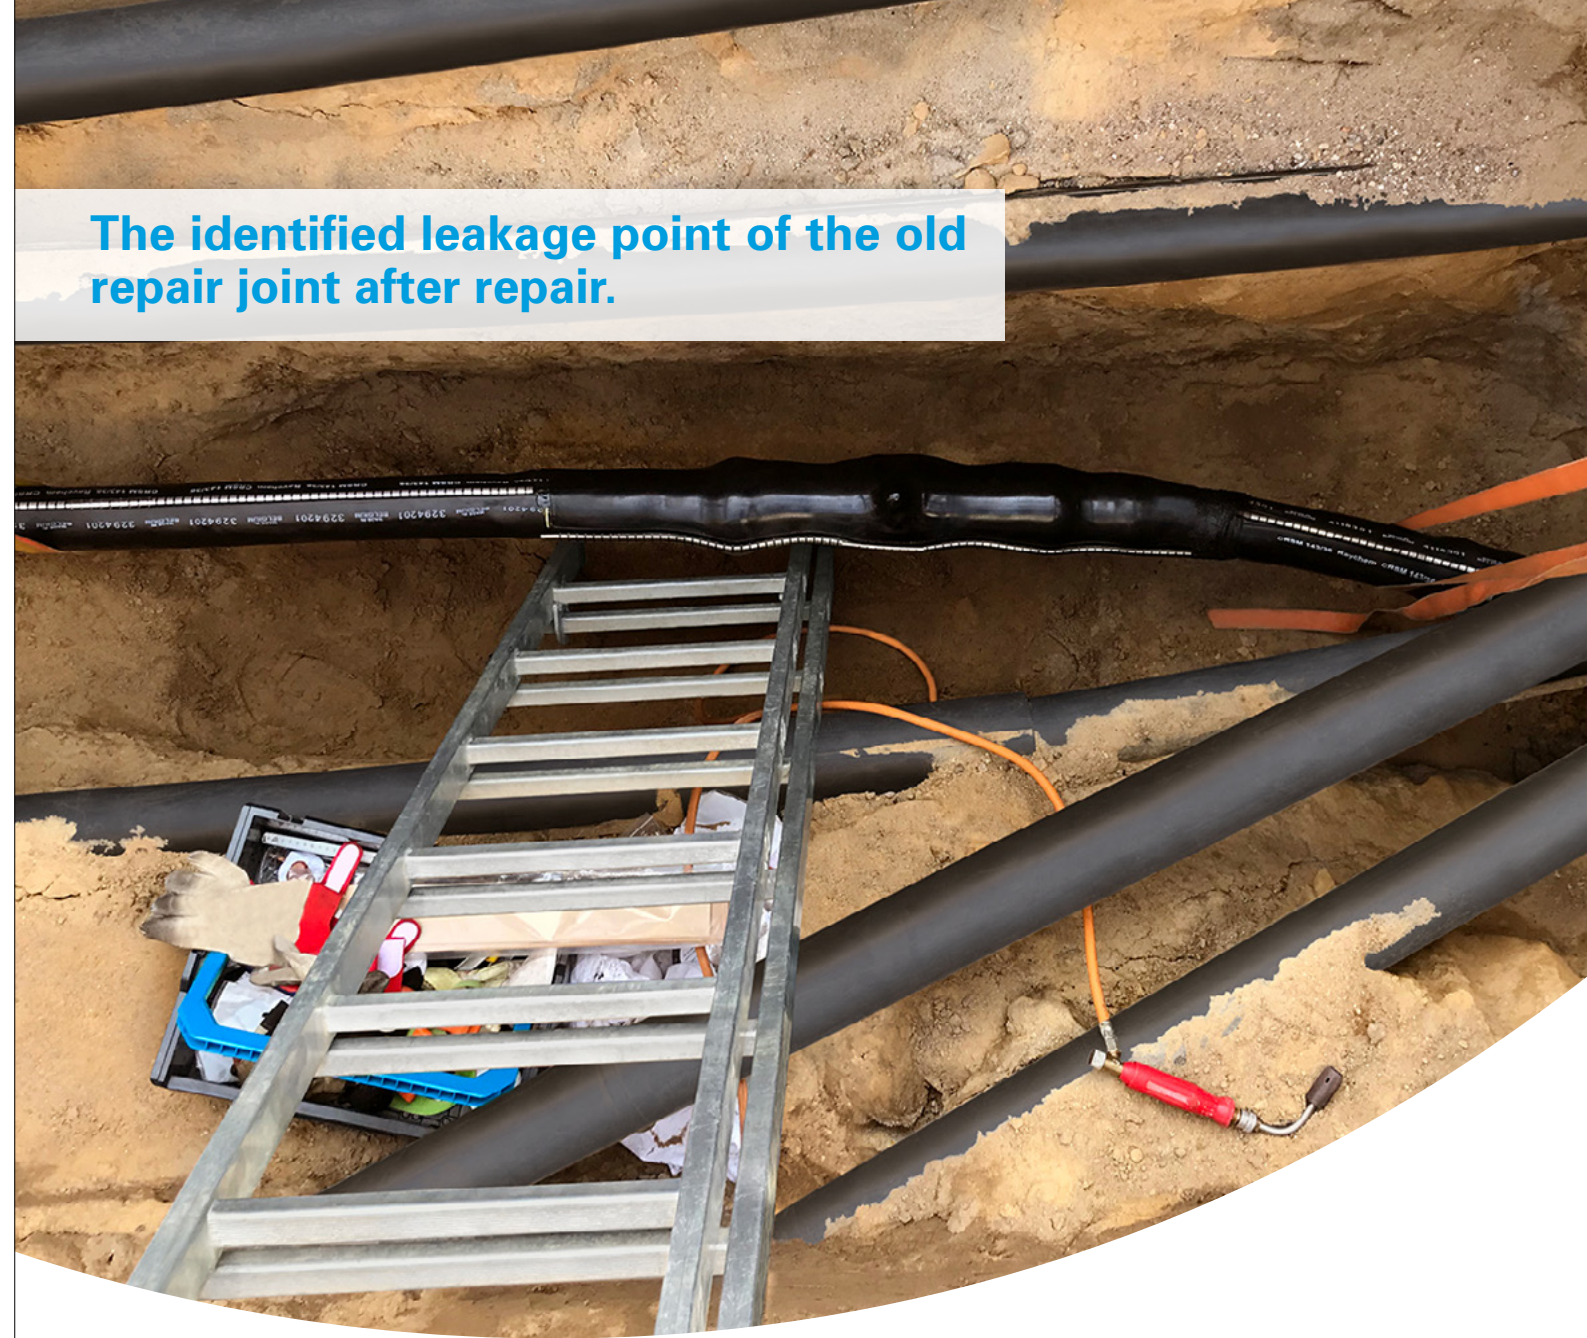
Brugg Cables, therefore, examined the three joints once again and was able to identify an oil leak in the first, an approximately 10-year-old repair joint. One repair seal showed leaks. The area around the seal was professionally sealed and reinforced. The pressure test after the repair showed no evidence of further relevant leaks, so the operation was completed.

The identified leakage point of the old repair joint after repair.
